Per Hoffmann
Deutsches Schiffahrtsmuseum
Bremerhaven (Germany)
hoffmann@dsm.de

THE BREMEN COG PROJECT

THE CONSERVATION OF A BIG MEDIEVAL SHIP

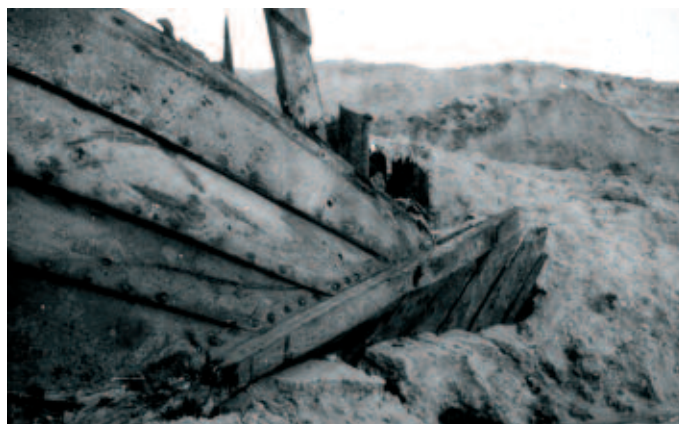
Fig. 2 - A strange hull in the river Weser: very wide clinker-laid planks fastened to each other with big, clenched iron nails run into straight stem posts fore and aft. These are features of a cog (Photo: K. Schierholz, Focke-Museum)

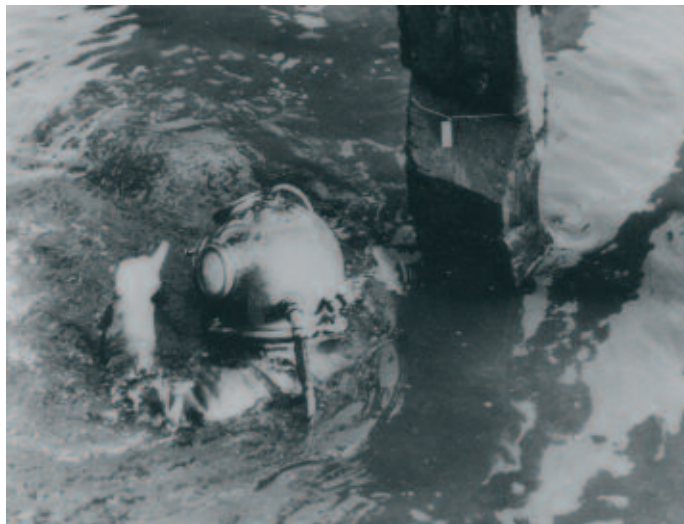
Fig. 3 - Feeling his way in near-zero visibility, a hard-hat diver tries to understand and to describe to the archaeologists on board the barge the structure of timbers he is going to attach to the crane (Photo: L. Kull, Bremen)

money nor time, with winter ice threatening, to arrange an excavation in a caisson, as was done for the Viking ships in Roskilde Fiord in Denmark. The cog had to be taken up timber by timber, with the help of a helmet diver groping his way in the dark brown water of the river (Fig. 3).

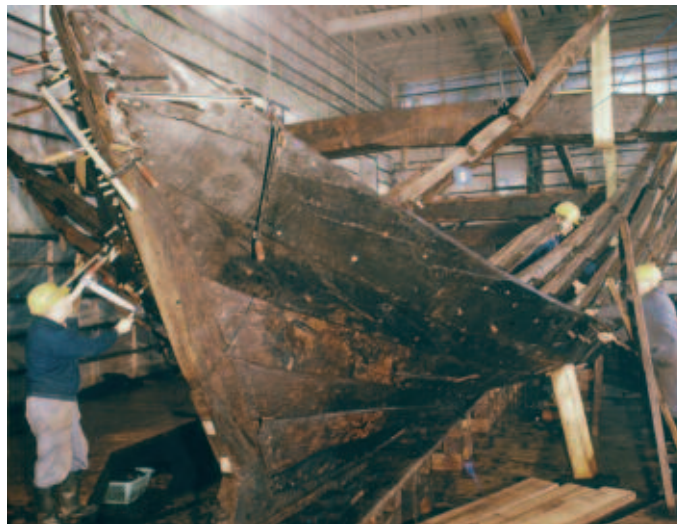
Fig. 4 - The 4th strake. Reconstructing the cog from waterlogged timbers called for 100% relative humidity - fog - in the cog hall and for constant spraying of the wood. Wooden dowels and treenails proved to be the best choice for assembling the wet timbers (Photo: G. Meierdierks, DSM)

The federal government of Germany, the government of Bremen, and the town of Bremerhaven established a foundation and built the Deutsches Schiffahrtsmuseum in Bremerhaven. In 1972 the ship's timbers could be transferred to the new museum. Master shipwright Werner Lahn and a few helping hands reconstructed the cog from the 2,000 wet timbers. She is 23.27 m long, 7.62 m wide and 7.02 m high from the keel to the top of the capstan on the castle deck [5]. A technique for gluing wet wood with a resorcinol resin had to be developed [6], and the traditional method of joining timbers with wooden dowels and nails had to be modified. A spraying system kept timbers and the ship wet all the time, for seven years, to avoid any drying damage prior to conservation (Fig. 4).

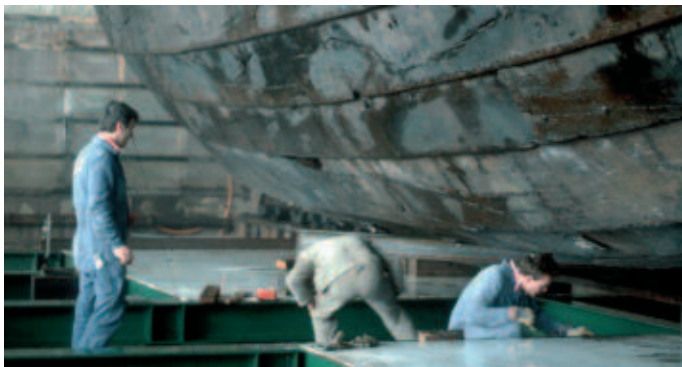
Fig. 5 - Building the stainless-steel conservation tank around the reconstructed cog (Photo: P. Hoffmann, DSM)

High molecular weight PEG 3000 or 4000 (MW 3,000 or 4,000) is solid, like stearin, at room temperature, and gives a good stability to the wood. But it permeates less degraded wood only very poorly, if at all. Low molecular weight PEG 200 or 400 permeates much better. But these PEGs are hygroscopic, and wood impregnated with them tends to absorb moisture from the air; it never really dries. Apart from that, low molecular PEG is liquid at room temperature, so it cannot strengthen heavily degraded wood. In 1981, the largest ever conservation tank was built around the cog (Fig. 5).

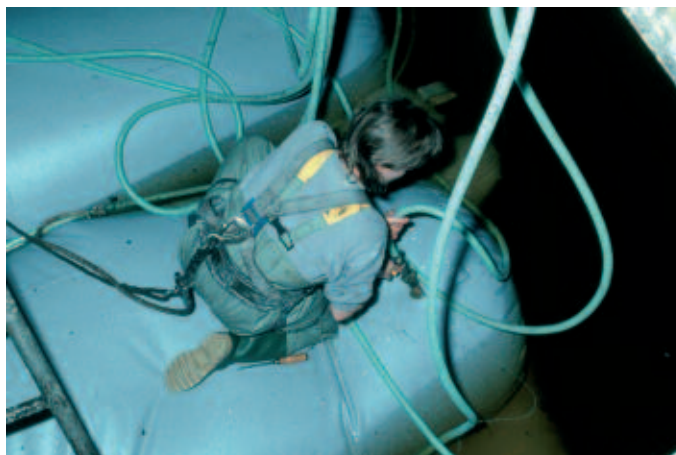
Fig. 6 - Filling displacement balloons in the tank with brine in a tropical climate. The PEG solution had to be kept at 40 °C (Photo: P. Hoffmann, DSM)

The days between the deliveries were devoted to work in the tank. We laid layer after layer of 5x1 m elastomer coated textile balloons under the ship and into its hold, and filled them with brine. The balloons were a means of reducing the active volume in the tank in order to save on expensive PEG. The heavy 18%-saltwater solution kept the balloons submerged in the PEG solution (Fig. 6). The balloons reduced the active volume by about 50%. Eighty tonnes of salt were used to produce brine. Thirteen tankers brought 270 tonnes of PEG 3000. These exciting weeks have been described in greater detail elsewhere [9].

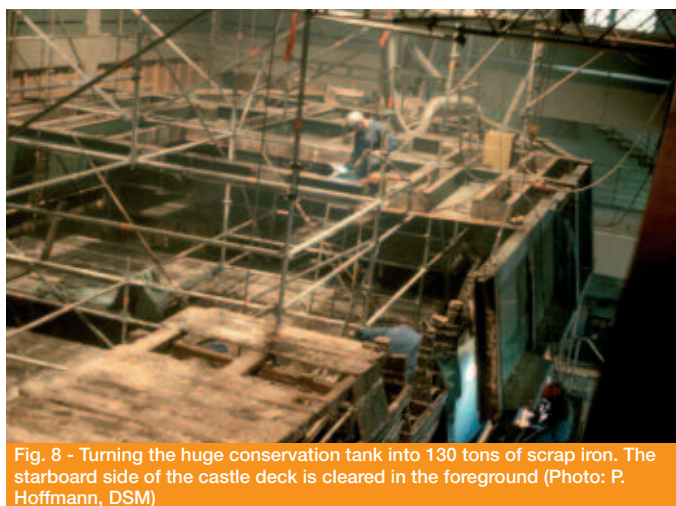
Fig. 8 - Turning the huge conservation tank into 130 tons of scrap iron. The starboard side of the castle deck is cleared in the foreground (Photo: P. Hoffmann, DSM)

The steelworkers from a nearby shipyard found it a rather intricate job to dismantle the tank. No pieces of steel, nor any droplets of liquid steel from their plasma torches, could be allowed to fall onto the ship in the tank. But once they had found out how to ensure that, it did not take long to cut the largest conservation tank in the world down to a heap of scrap iron (Fig. 8).

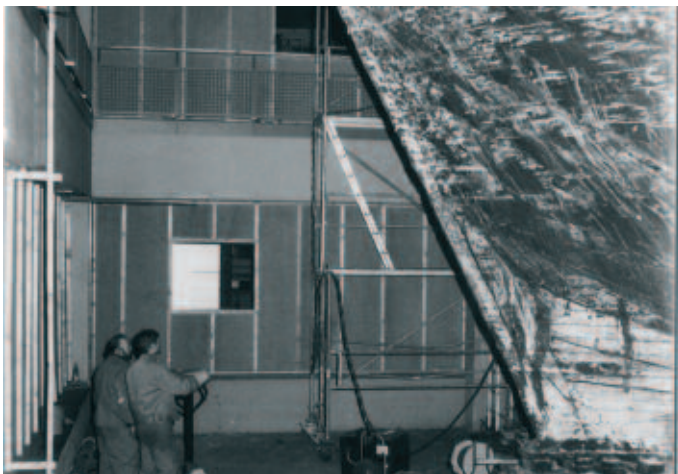
Fig. 9 - Due to the slow pumping-off, the concentrated PEG 3000 solution has solidified on the timbers of the hull (Photo: E. Laska, DSM)

By Christmas 1999, the cog stood free once again in the cog hall of the museum. She looked like a ship on an arctic expedition, encrusted in white, solidified PEG-solution (Fig. 9). Cleaning was tedious. But with a carefully applied steam jet, and with brushes, sponges, and spatulas, we could remove the PEG without washing too much of it out of the wood surface.

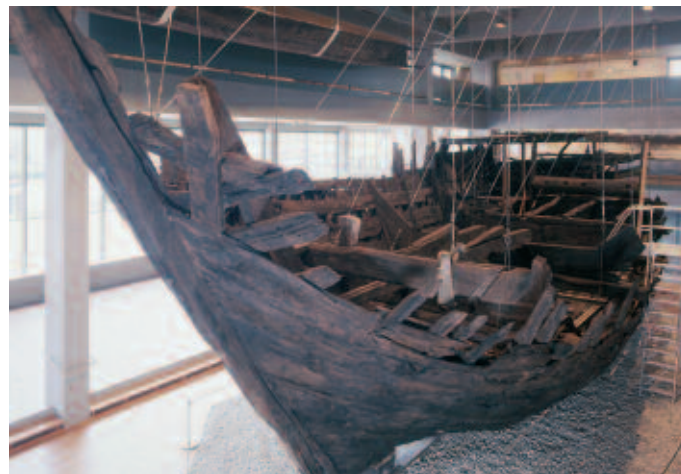
Fig. 10 - A view into the Cog. The port side has eroded away down to below the huge cross-beams. The asymmetric steel-rod-system transfers most of the hull's weight to the ceiling (Photo: E. Laska, DSM)

The cog is a nearly complete ship: only the upper part of the port side has eroded away in the riverbed. Visitors standing at the foot of the stem, or at the stern, are amazed at the impact of the bulky and high hull, and at the same time delight in the elegant strakes of the enormously wide planks. The cog seems to be ready to move at any moment (Fig. 10 to 12).

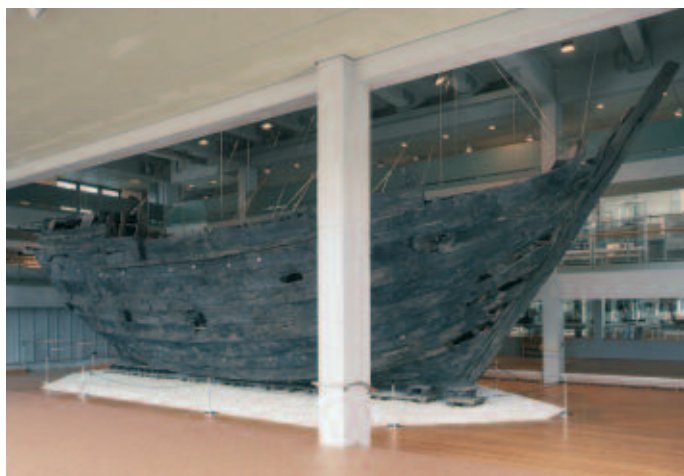
Fig. 11 - The Bremen Cog as she stands in the Deutsches Schifffahrtsmuseum (Photo: E. Laska, DSM)

The Bremen cog project has taken 38 years, from the salvage to the presentation of the stabilised ship in the museum. Two major decisions characterise this project, and they were both successful. First, we rebuilt the ship from its waterlogged timbers before conservation, as the planks would have become stiff and unpliable in conservation. And second, we stabilised the ship's timbers with a

specially developed two-step treatment using low molecular PEG and high molecular PEG. This two-step PEG-treatment has meanwhile been adopted for the conservation of other archaeological ships, such as the Kinneret boat in Israel, the Shinan Treasure Ship in Korea, and the Mary Rose in Britain. The treatment is expensive, but it gives excellent results with multi-quality timbers.
